Report 1832

BLAST EFFECTS ON U. S. ARMY  
WATER-STORAGE CONTAINERS

October 1965

U. S. ARMY ENGINEER RESEARCH AND DEVELOPMENT LABORATORIES  
FORT BELVOIR, VIRGINIA

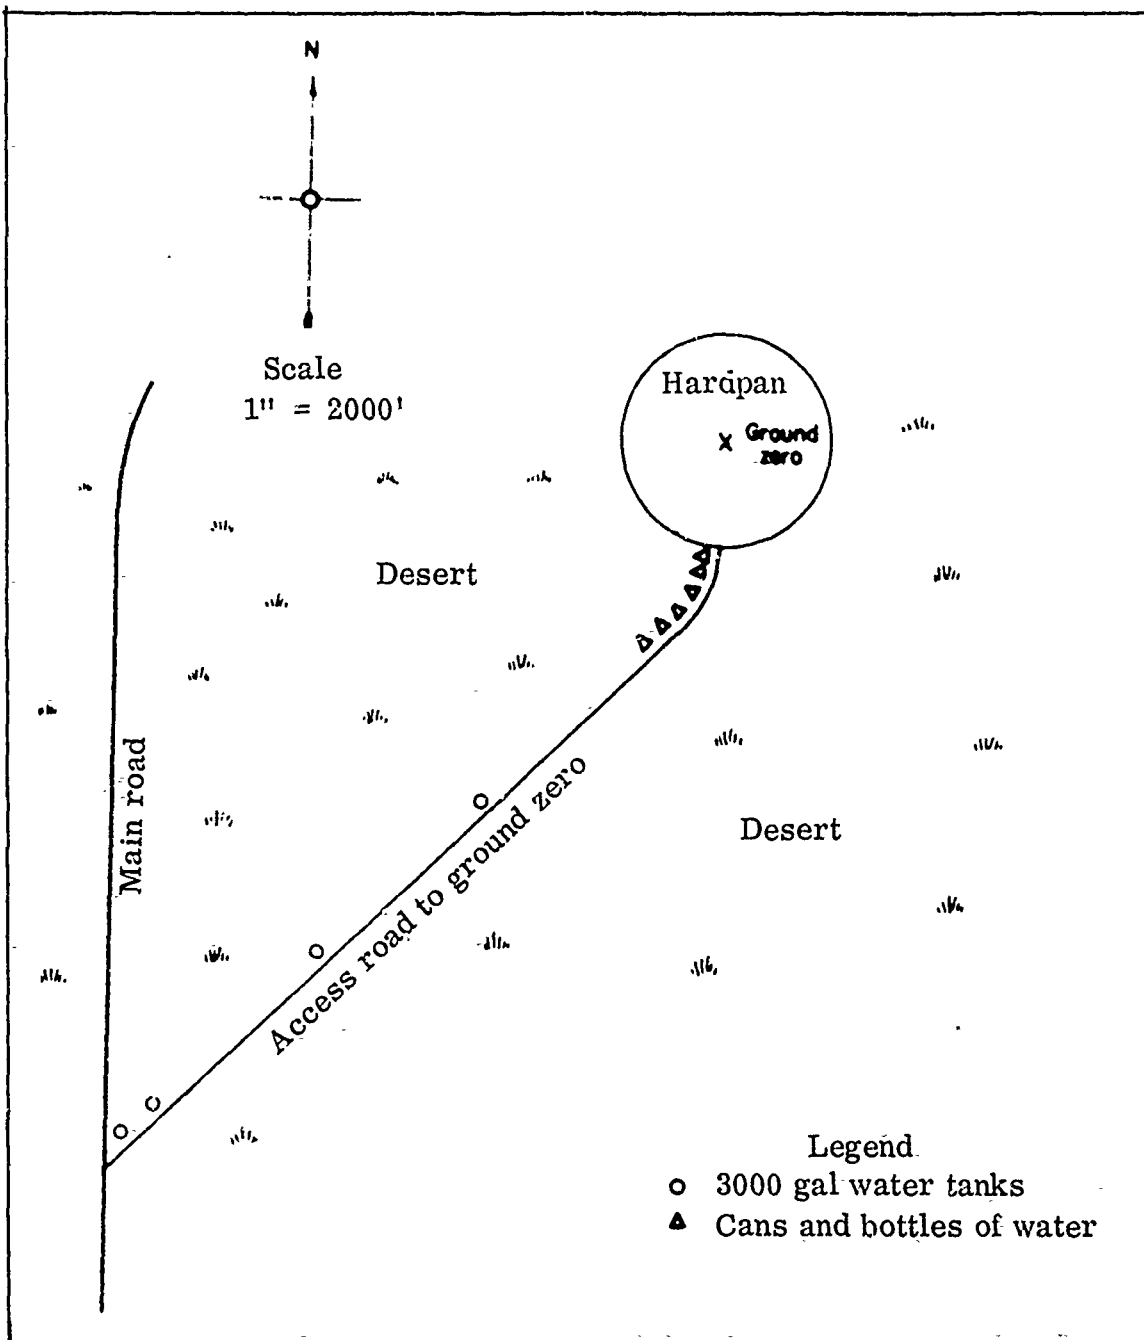
Fig. 1. Operation BUSTER: Location of water-storage tanks.

It is important to determine how much blast pressure these tanks can withstand under field conditions and what can be anticipated with regard to air-borne dust contamination. The only previous information available concerning blast effects on military storage containers was obtained from tests on the standard Army GRS coated, nylon fabric, 3000-gallon tanks. In Project 3.9, Operation BUSTER, four 3000-gallon tanks were placed in a direct line at points 2000, 3000, 4000, and 4291 yards from ground zero (see Fig. 1) (1).<sup>1</sup> The tanks were filled with local drinking water from a 900-foot well at Frenchman Flat (AEC's Nevada Test Site) and were left uncovered. The area was entered 3½ hours after the blast (Shot EASY, 31 KT nuclear air burst), and all tanks were examined for blast damage. Table I shows the effects of the blast on the tanks.

Tank 1, at 2000 yards, contained some twigs driven perpendicularly through the tank sidewall and showed signs of blistering and charring.

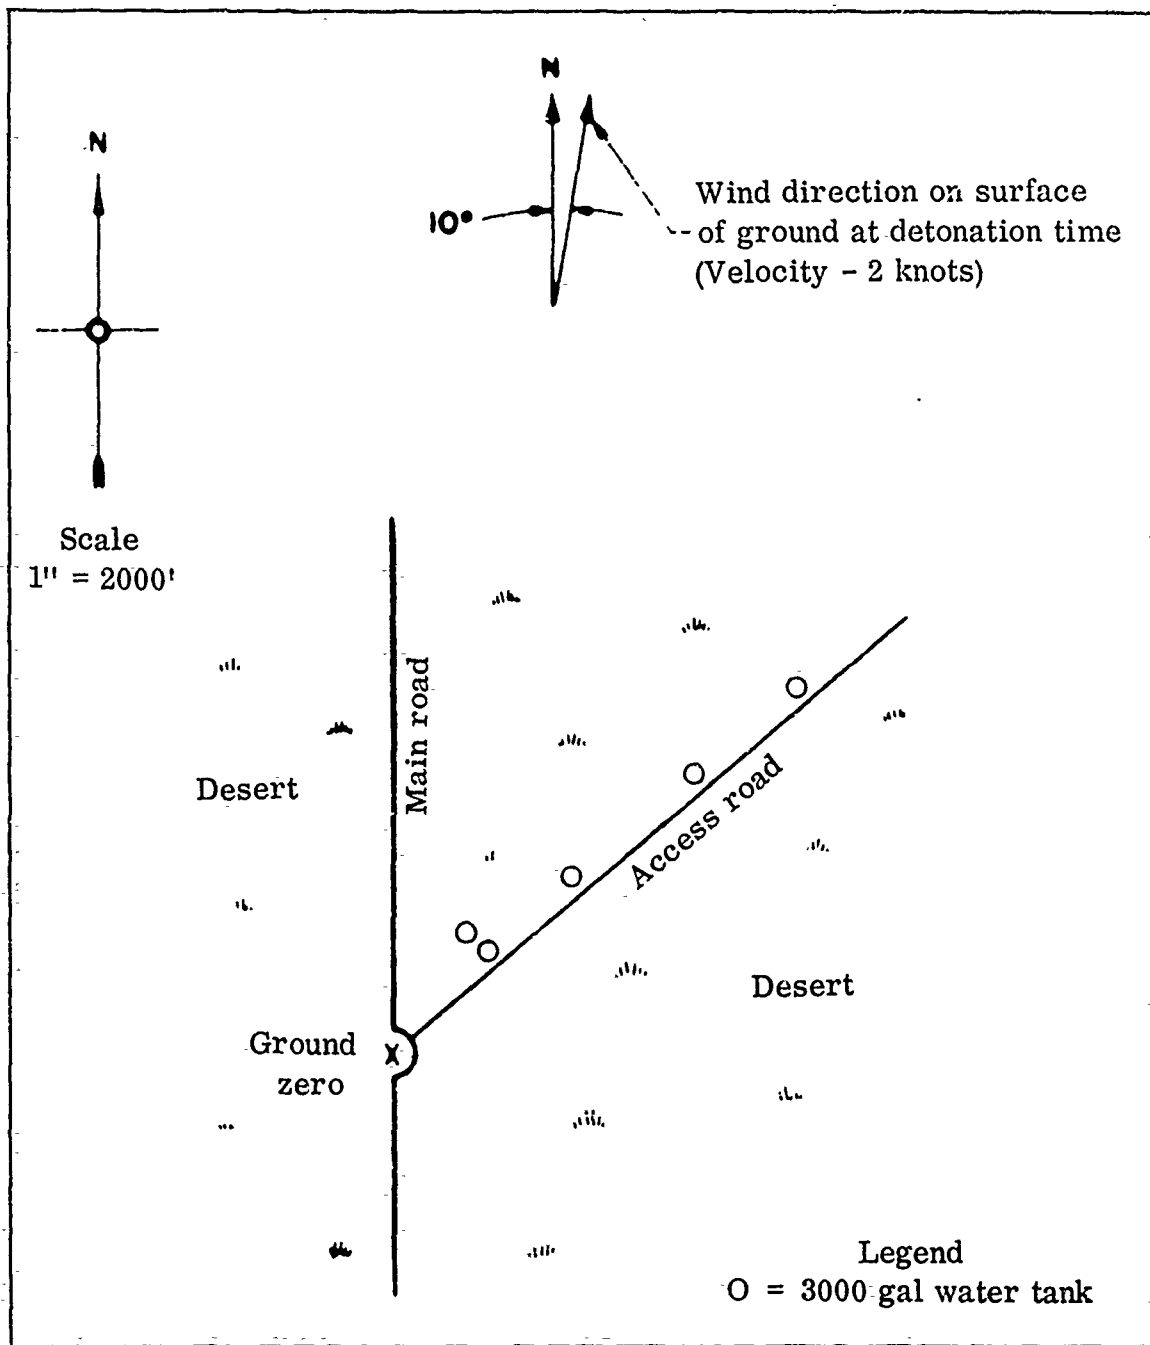
Fig. 2. Operation JANGLE: Location of water-storage tanks.

In Project 6.8, Operation JANGLE, four 3000-gallon water tanks were placed on a line 50 degrees East of North from ground zero at distances of 500, 925, 1500, and 2030 yards (see Fig. 2) (2). The tanks were filled with local drinking water from well supplies at Frenchman Flat and left uncovered. In addition, one covered, 3000-gallon tank was installed at 500 yards. All tanks were placed at ground level and were not fortified. The results indicated that all of the tanks essentially were undamaged following a 1.2-KT nuclear surface burst. This detonation produced an overpressure of 5 psi and a thermal flux of  $20 \text{ cal/cm}^2$  at a distance of 500 yards from ground zero. The top cover sheet of the covered tank located 500 yards from ground zero partially was torn from the ring loops and had dropped into the tank. The wooden staves facing ground zero were charred slightly.

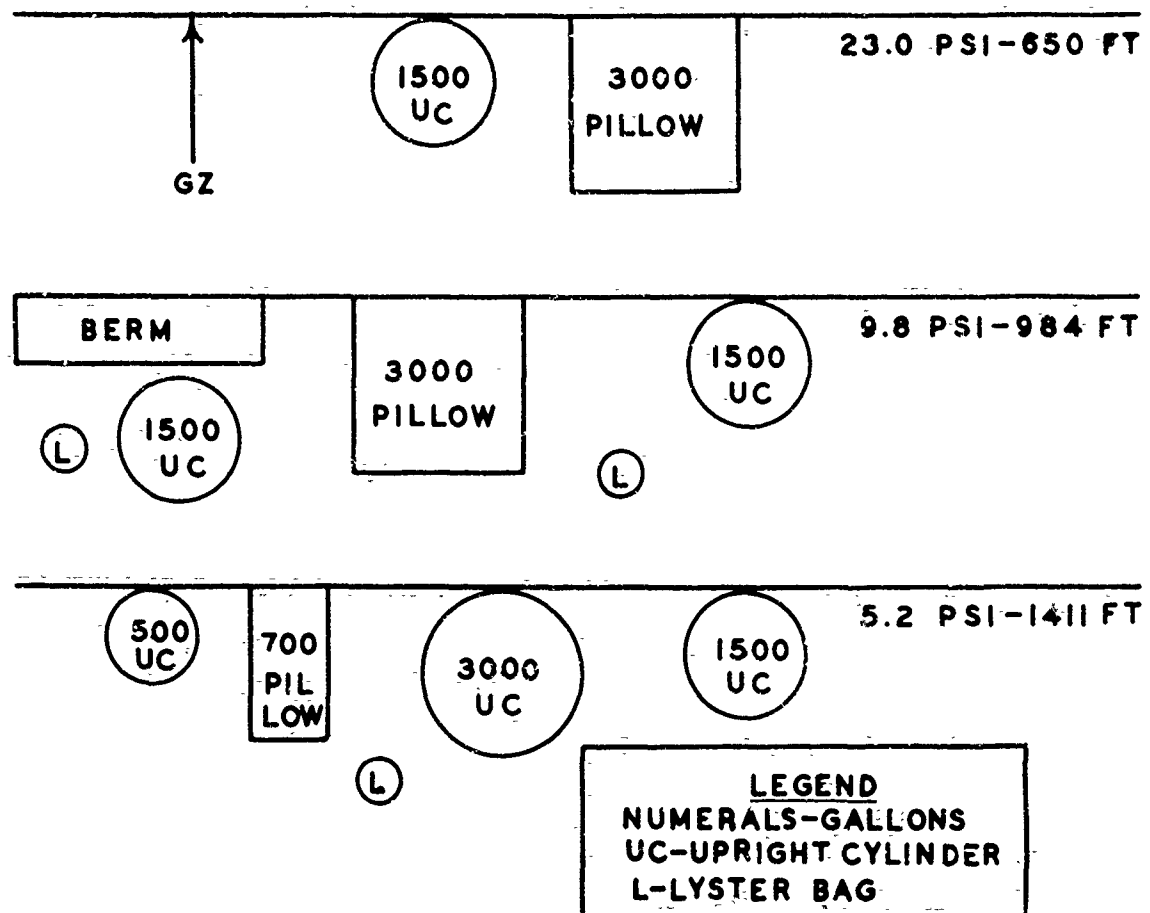
Fig. 3. Tank layout at three overpressure sites.

The tanks were installed at three locations (see Fig. 3) on a radial line from ground zero (GZ) and were filled with locally supplied tap water. The upright cylinders were covered, which is typical of field distribution tanks containing drinking water. The most remote site was located 1411 feet from GZ and consisted of an area approximately 65 feet perpendicular to the GZ radius and 25 feet wide. A 3000-gallon upright cylinder, a 1500-gallon upright cylinder, a 500-gallon upright cylinder, a 700-gallon pillow, and a 36-gallon lyster bag were installed at ground level without berm protection. An intermediate site, established at a point 984 feet from GZ, consisted of an area approximately 70 feet perpendicular to the GZ radius and 35 feet wide. A 1500-gallon upright cylinder, a 3000-gallon pillow, and a 36-gallon lyster bag were installed at ground level without berm protection. A 1500-gallon upright cylinder and a 36-gallon lyster bag were installed behind a protective berm (see Fig. 4). Predicted overpressures at the remote site and the intermediate site were 5.0 and 9.7 psi respectively (4).

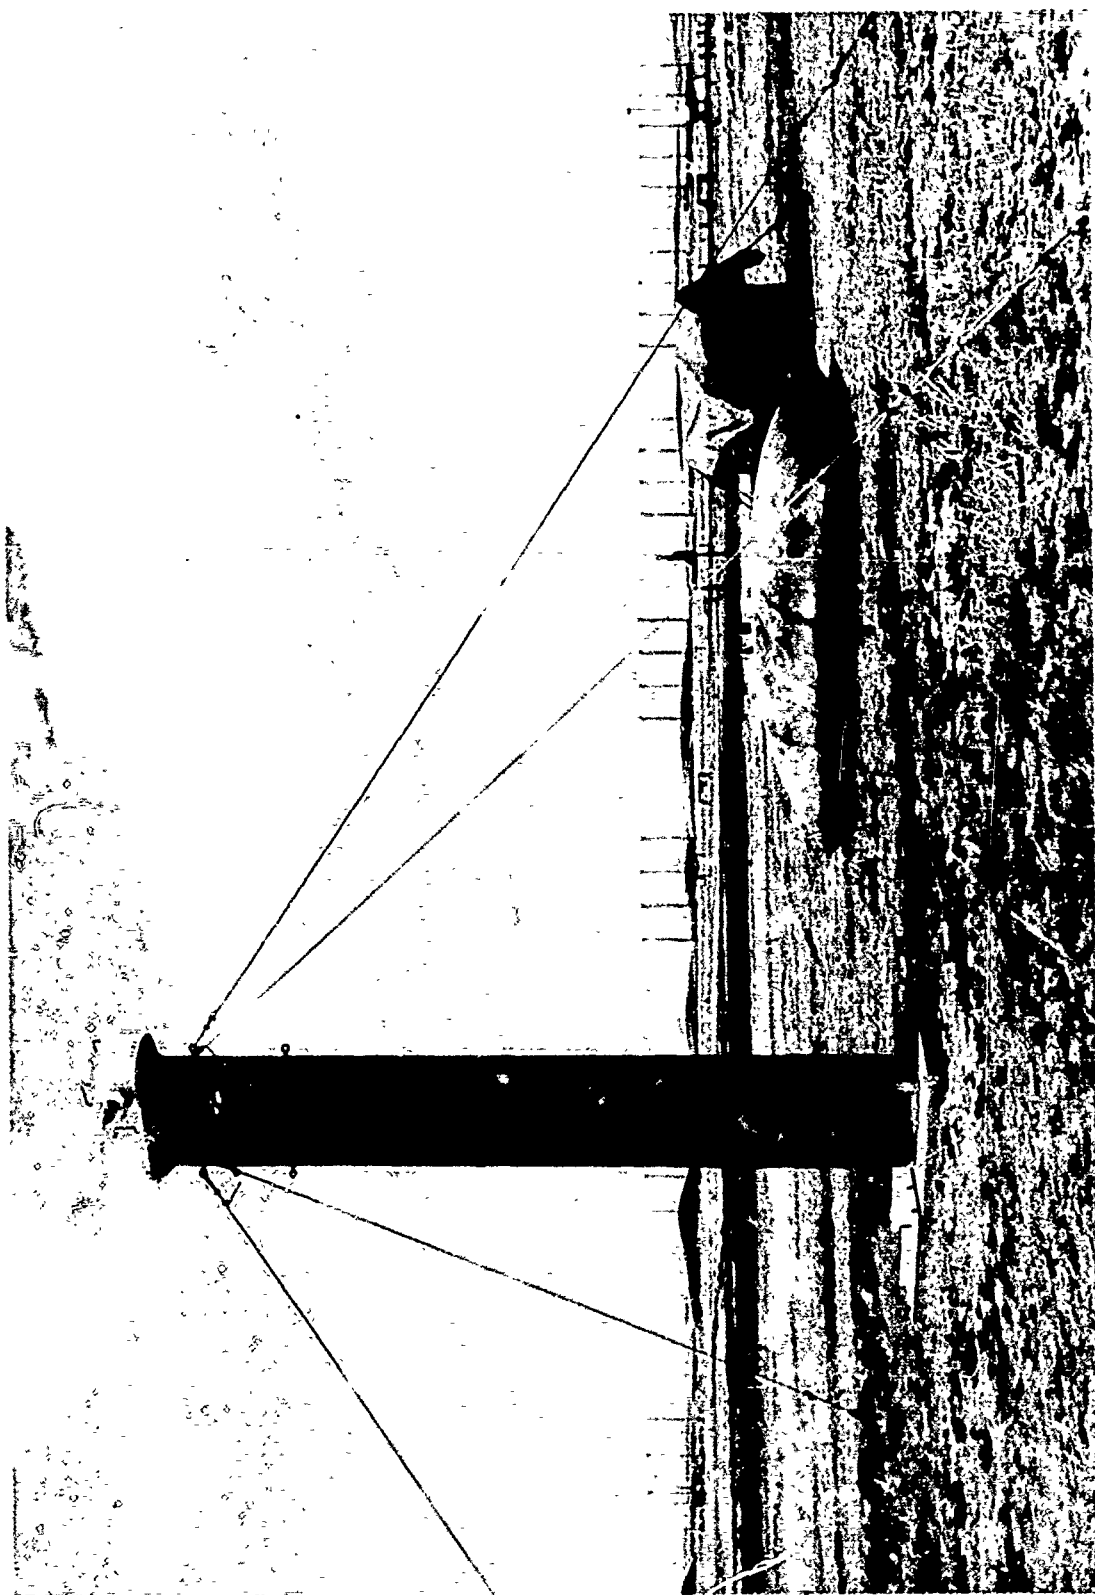
Fig. 5. Pre-shot view of tanks and camera tower at the 23.0-psi overpressure site.

It is apparent, by comparison of Figs. 5 and 6, that severe damage was encountered at 23.0 psi.

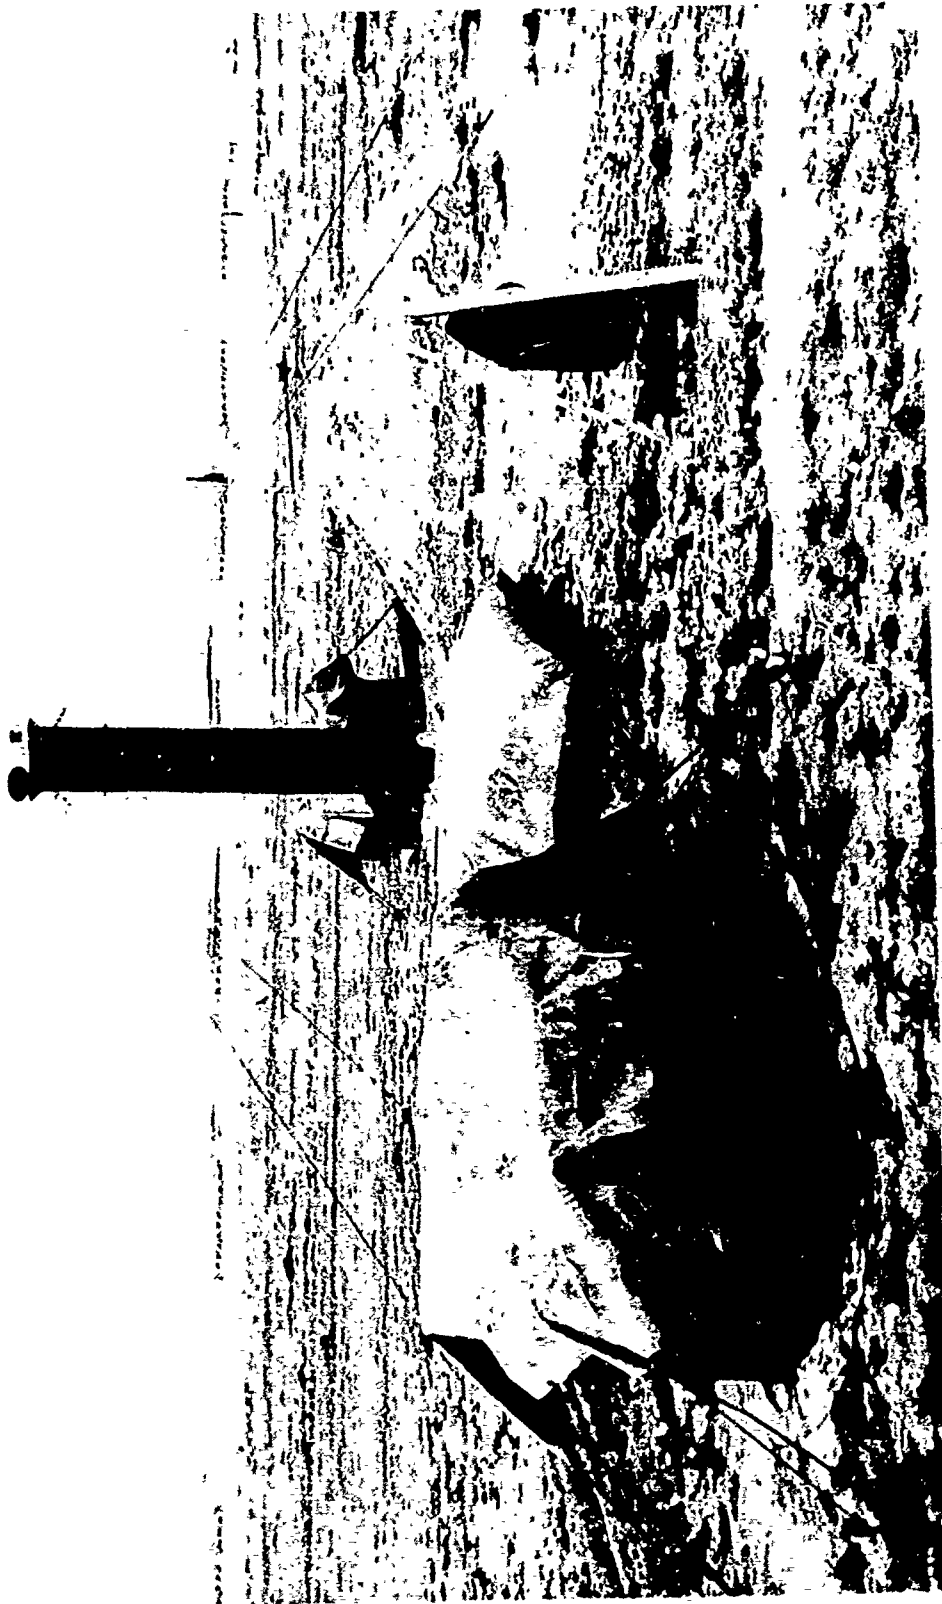
Fig. 7. Pre-shot view of 9.8-psi overpressure site.

At 9.8 psi, damage was evident (see Figs. 7, 8, and 9). The greatest damage at this area was to the unprotected, 1500-gallon, upright-cylinder tank. There was an 18-inch-long by 7-inch-high gash, 31 inches from the bottom of the tank, facing GZ. Upon draining and subsequent inspection of the tank, a  $1\frac{1}{2}$ -inch-diameter, 46-inch-long steel conduit section was found lying to the rear of the tank (see Figs. 10 and 11). All equipment in the 9.8-psi area was covered with a heavy layer of fine, grey dust. The 3000-gallon pillow tank survived both overpressure and missile damage. All tank covers of the upright cylinders were ripped off, and the water was contaminated with air-borne dust. The burned and dust-covered area was an area encompassed by a circle with an 1100-foot radius from GZ.

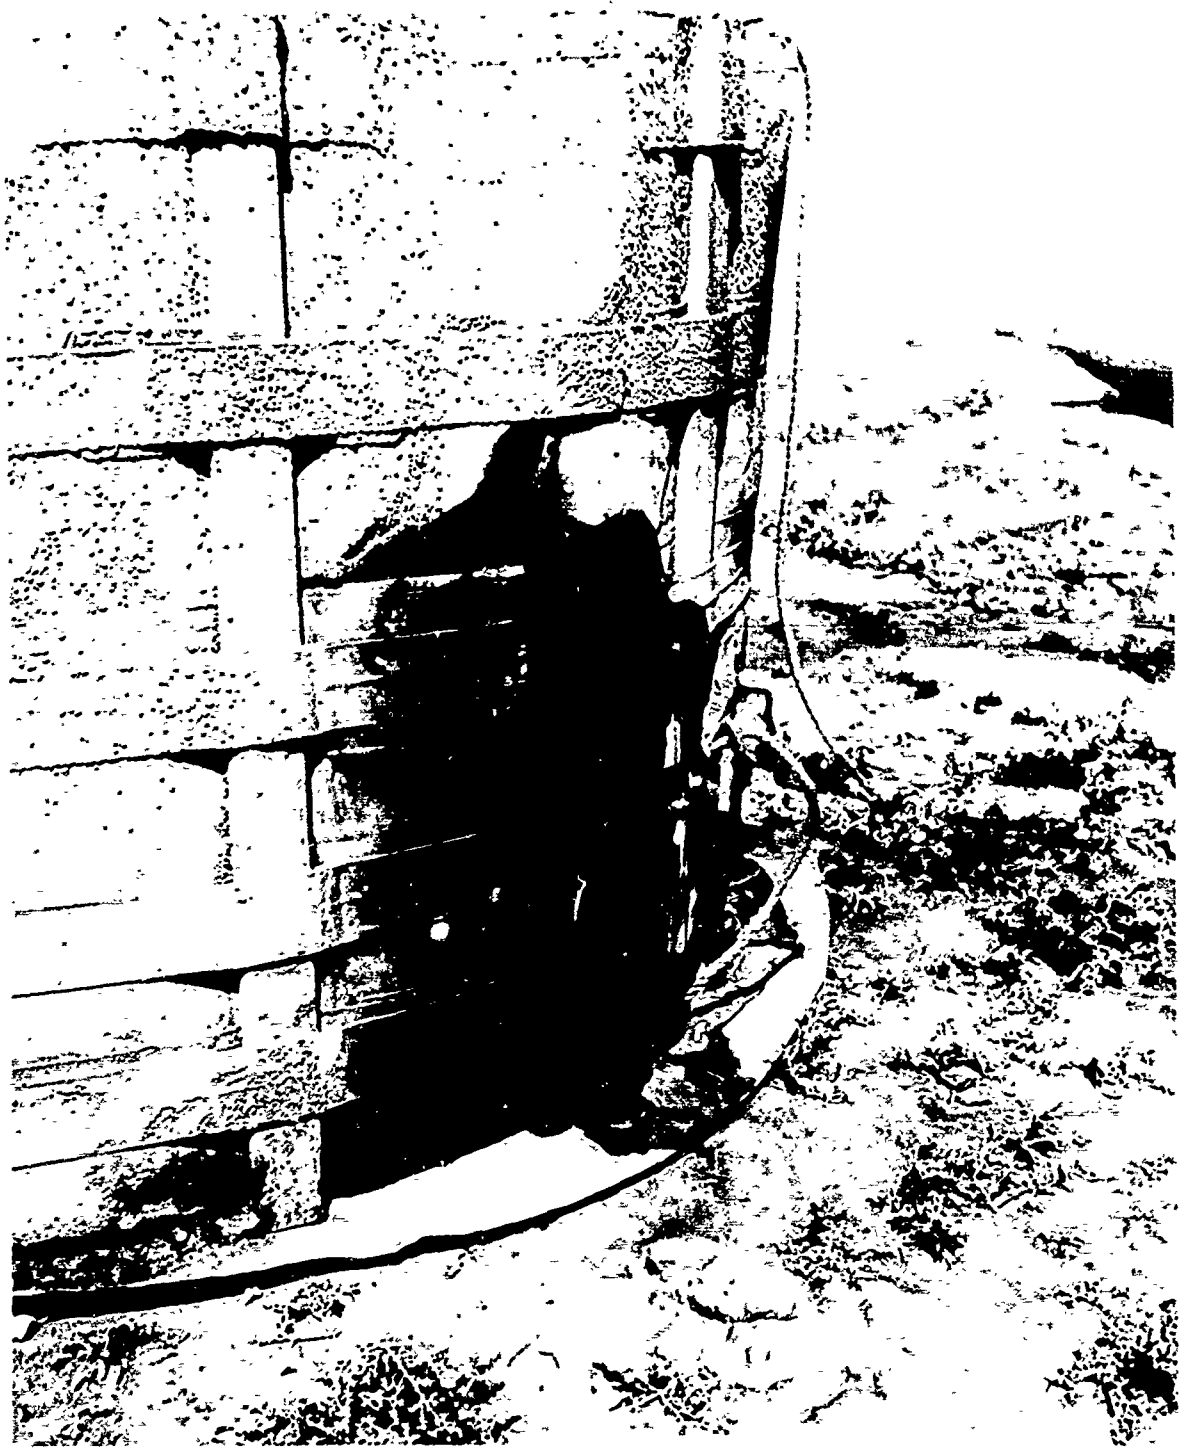
Fig. 10. Close-up of missile damage to 1500-gallon tank at 9.8-psi overpressure site.

\* Rip in this tank in the shape of an inverted "T"; 18 in. long and 7 in. high. Damage due to missile.

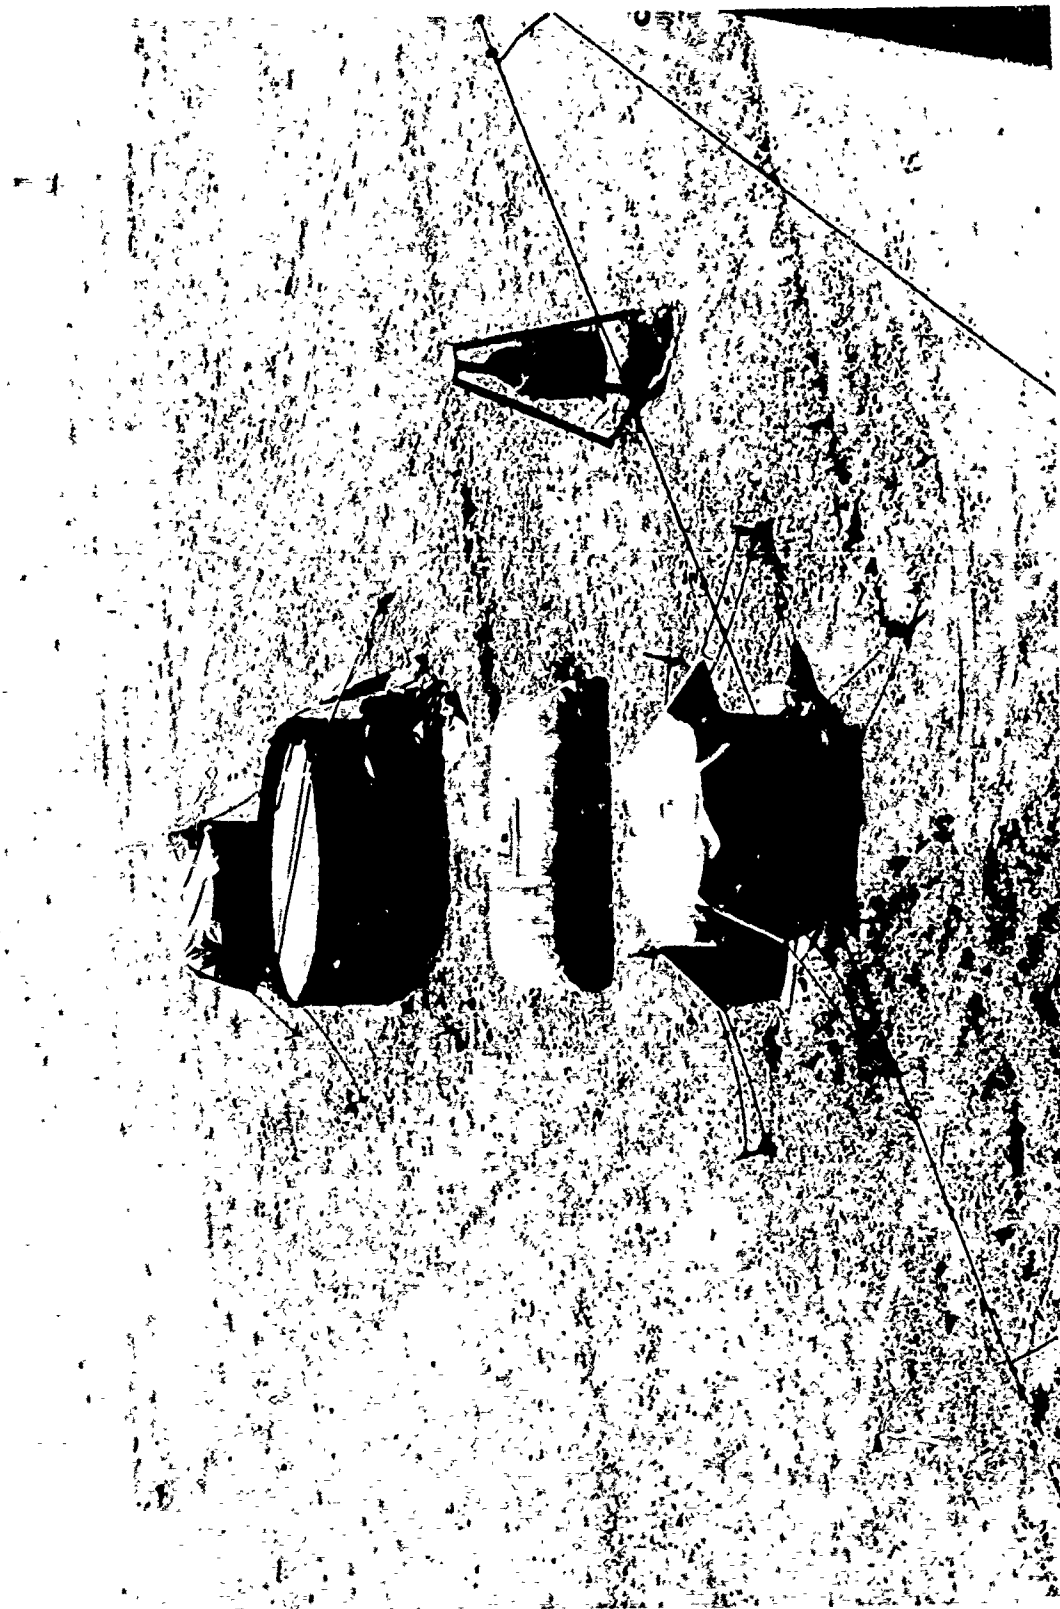
Fig. 13. Post-shot overall view of area at 5.2-psi overpressure site.

Since the 5.2-psi area lay beyond this 1100-foot radius, at 1411 feet, contamination of the water in the tanks at this area was minimal. Figures 12 and 13 show the blast effects on the water containers at 5.2 psi. The cover cloth on the 3000-gallon upright cylinder was ripped off, and the large spreader bar was thrown to the rear. Many of the metal grommets (ring loops) did not hold firm. The cover cloth on the 1500-gallon tank had fallen into the rear of the tank due to a broken guy rope and a guy rope stake. Water loss was minimal.
